# Manhole Inspection Summary

Manhole # S29CC1014MH

Insp Date: **12/12/06 2:30 PM**

**Location** Address: **3619 CHESTNUT AVE**

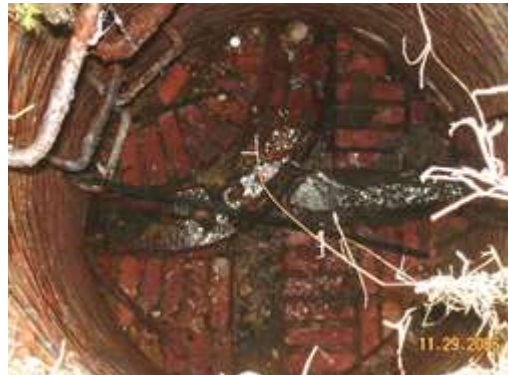
Top View

Corroded steps. Bench and Channel debris.

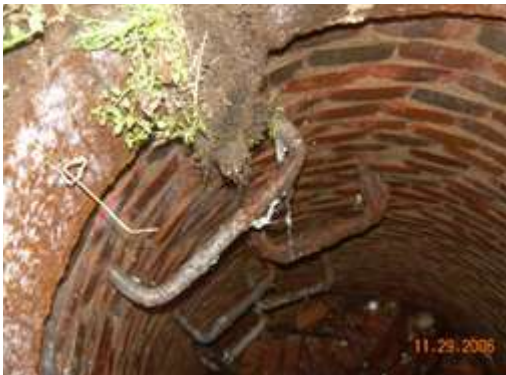
Defect

Corbel and Barrel infiltration. Corroded steps

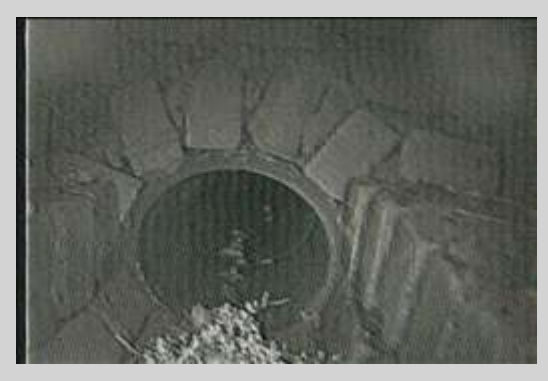
Pipe Out @ 12 O'Clock

Barrel deterioration and infiltration. Channel deterioration.

Infiltration: **Evidence** Pipe Seal Cond: **Cracked**

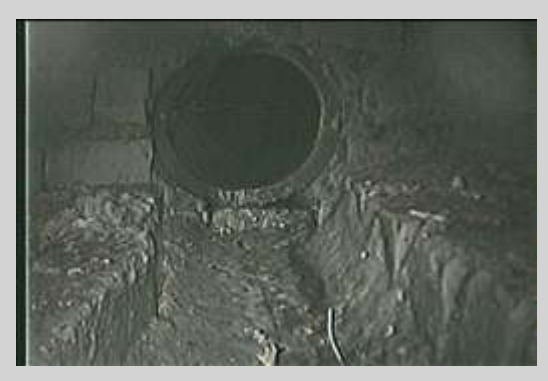
Pipe In @ 3 O'Clock

Infiltration: **Evidence** Pipe Seal Cond: **Cracked**

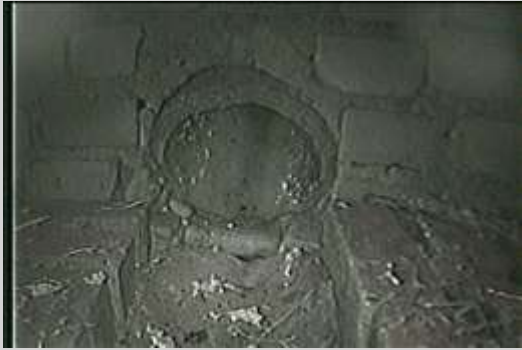
Pipe In @ 6 O'Clock

Pipe Seal Cond: **Cracked**

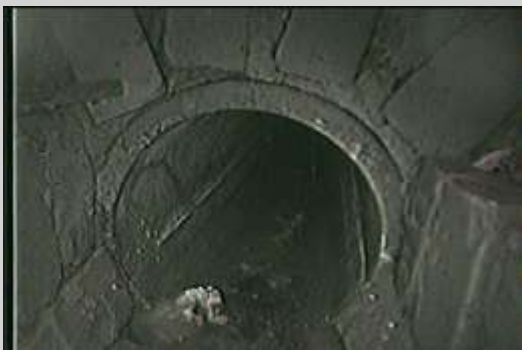
Pipe In @ 9 O'Clock

Deposits: ☐ None ☒ **Mud** ☐ Sludge ☒ **Debris** ☐ Grease

Silt Depth: **0** (in.) Deposits Extent: **Light**
